### SEAL FAILURE PROTECTION

# Modelo 590

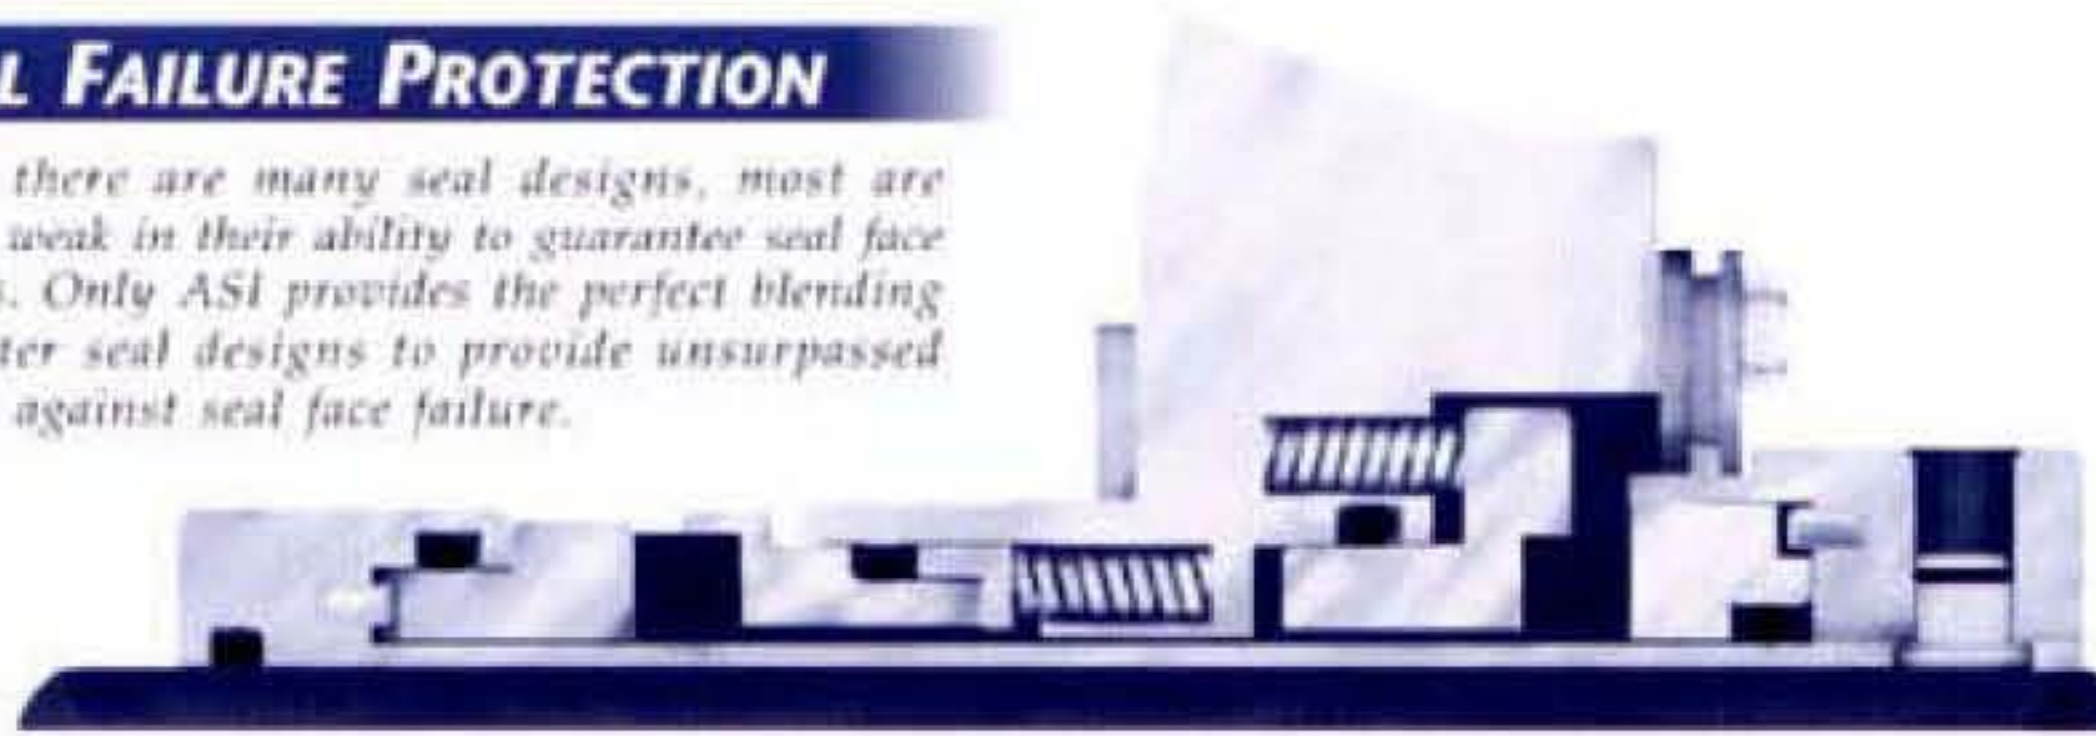
Although there are many seal designs, most are inherently weak in their ability to guarantee seal face squareness. Only ASI provides the perfect blending of the better seal designs to provide unsurpassed protection against seal face failure.

First, the surface for the back of the rotary has been machined at a perfect right angle to the axis of the pump shaft. This eliminates the possibility of face misalignment due to o-ring swelling [See Fig. 1], as well as allowing o-ring operation at cooler temperatures due to the dissipation of heat. The location of the drive pin protects against catastrophic seal face failure by localizing any chips or cracks that may develop. This prevents the almost inevitable spreading of these cracks to the seal face that would occur if the drive mechanism was closer to the face [See Fig. 2]. As an added safety feature, ASI has encased the most crucial part of the seal faces in metal, protecting both plant personnel and the environment from seal face failure. ASI has also engineered a natural seam or parting line into the seal design to aid in the removal of the face, without which, field repairability would be virtually impossible [See Fig. 3].

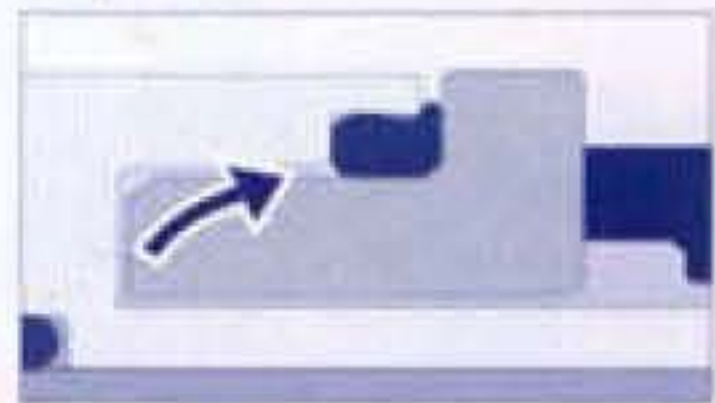
Fig. 1

The rotary face of this design rests upon an o-ring, which will often swell. This swelling (not necessarily uniform in shape) will push the rotary seal face axially and cause the seal faces to misalign. In addition, vacuum service can draw this o-ring completely out of its groove.

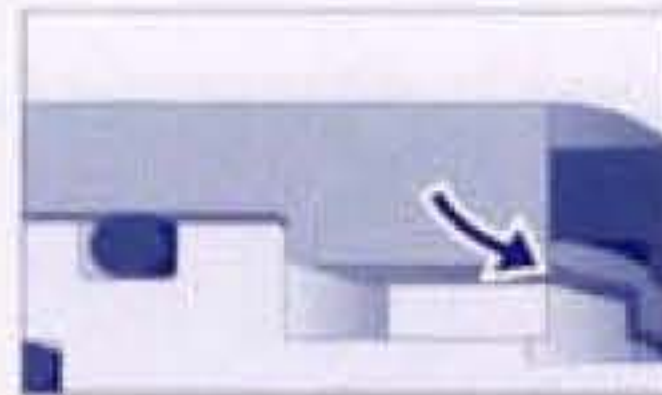
Fig. 2

At pump startup, break-away torque causes a drive lug to hit against the side of a groove beneath the face causing chipping or breakage. Centrifugal force sends any hard, sharp fragments into the seal faces. Also, constant re-engagement with axial movement causes a phenomenon known as "ramping" which provides a sloped surface for the seal face to ride up on. When these forces overcome the tensile strength of the seal face, breakage occurs.

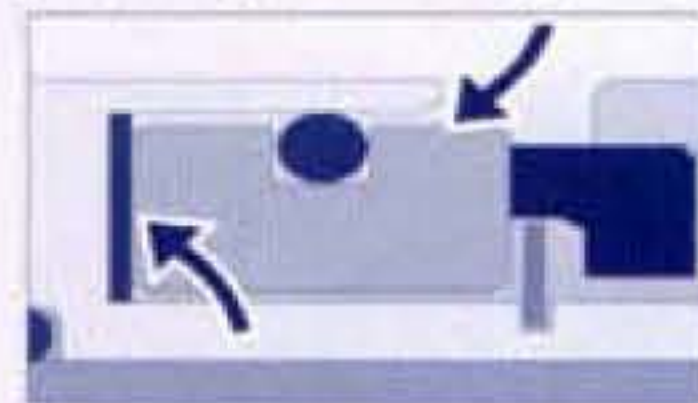
Fig. 3

Resting the rotary seal face on such materials as gaskets (without thickness accuracy of machined parts) may cause the resting surface to become uneven from variables such as manufacturing variances, chemical decomposition or swelling. This, in turn, will produce face misalignment.

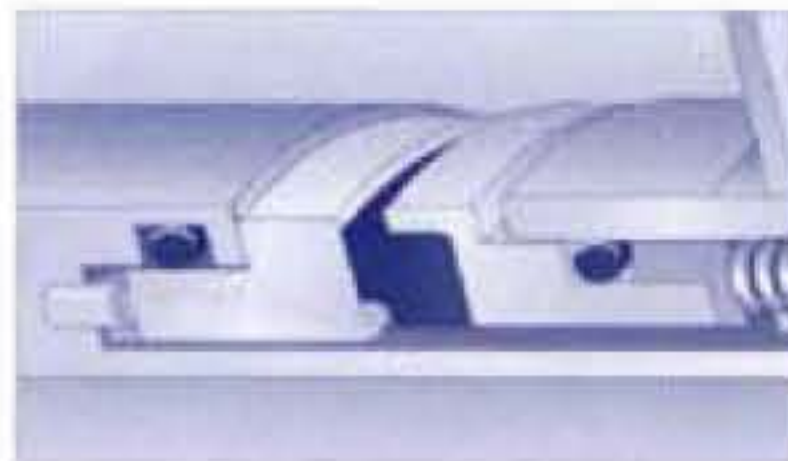
### STATIONARY DESIGN

The Model 590's stationary design derives sealing face alignment from the pump shaft and not the stuffing box or seal gland plate. Perfect sealing face squareness is automatic upon installation and requires no gland plate adjustments. Springs don't rotate with the shaft, nor do they flex. Under normal conditions, the Model 590 adjusts one time upon installation and thereafter only to compensate for the limited wearing of the sealing face surfaces.
